June 28, 2019 File No. 262018.063

Subject: Department of Natural Resources Washington Geological Survey,

School Seismic Safety Assessment Project, Contract No. AE 410 -

Seismic Evaluation for Wilson Creek School District

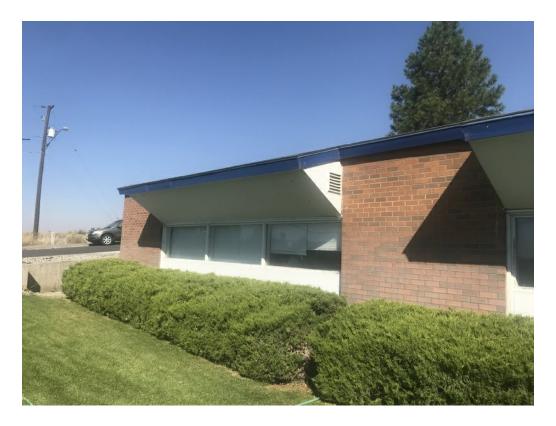
Figure 1-3. Southwest corner of the building.

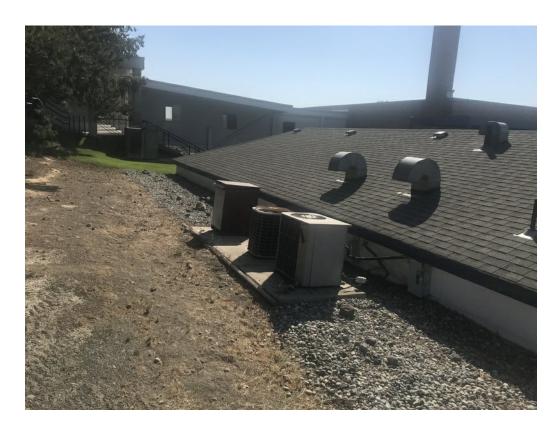
Figure 1-4. North side of building.

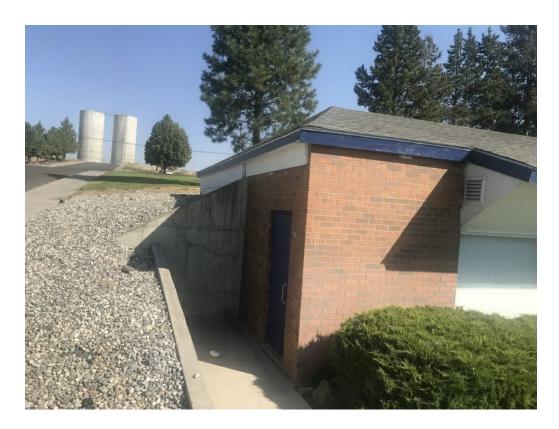
Figure 1-5. West side of building.

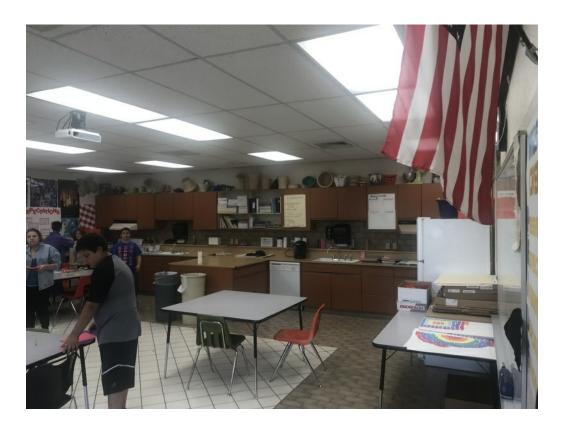
Figure 1-6. Home economics classroom.

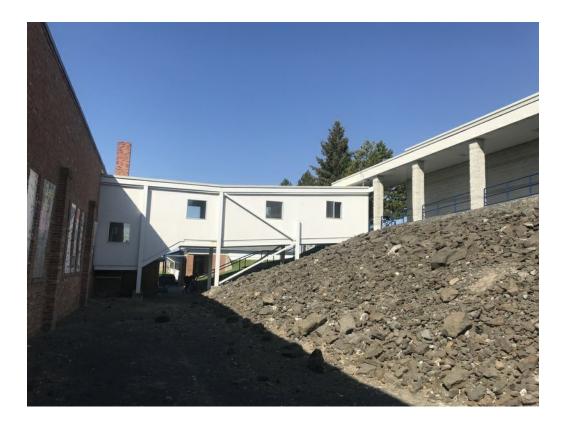
Figure 1-1. East side of bridge connecting gym to main building

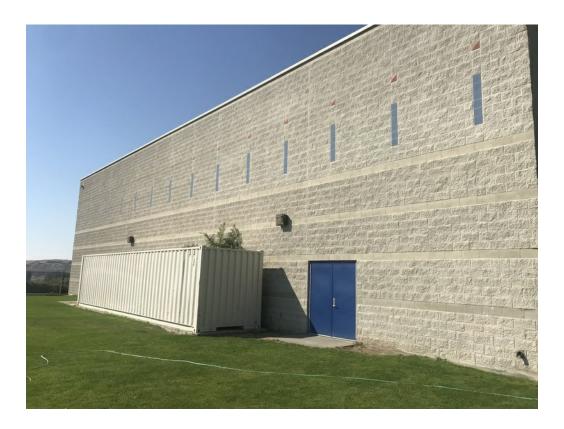
Figure 1-2. East side of building.

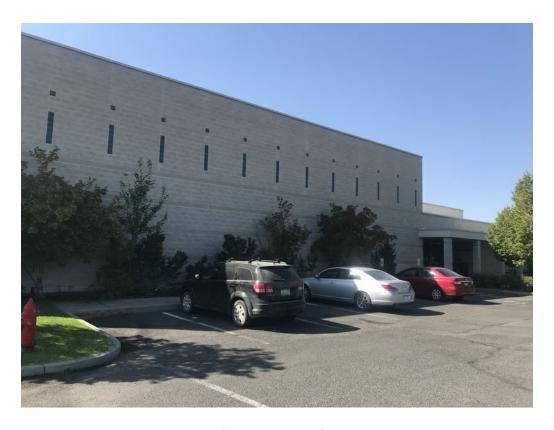
Figure 1-3. North side of building.

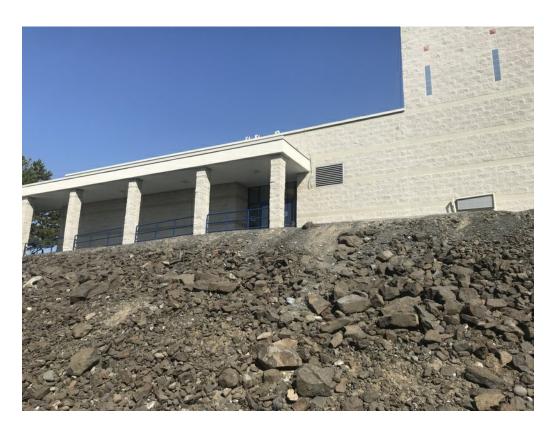
Figure 1-4. South side of building.

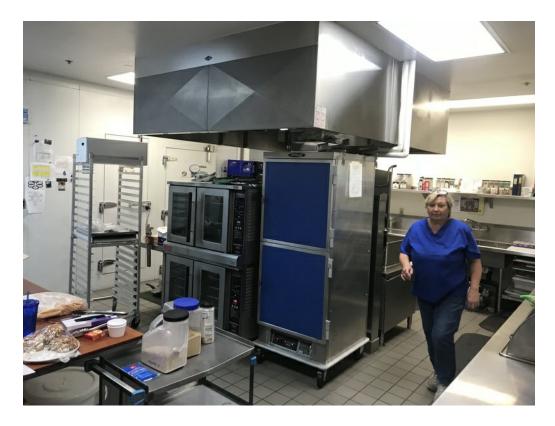
Figure 1-5. Cafeteria kitchen.

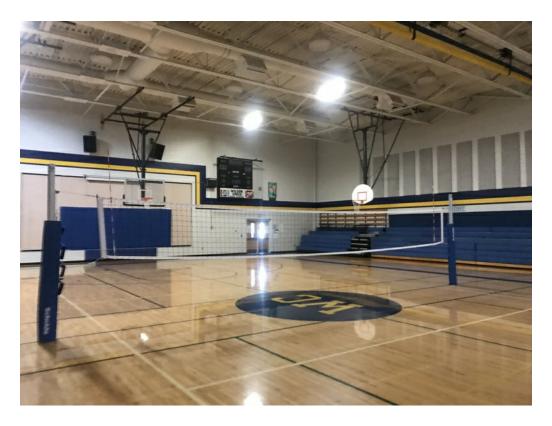
Figure 1-7. Gymnasium with visible open-web steel joist roof construction.

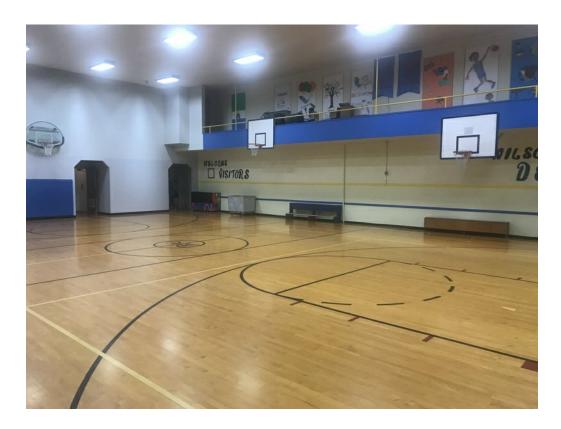
Figure 1-2. Second floor gymnasium.

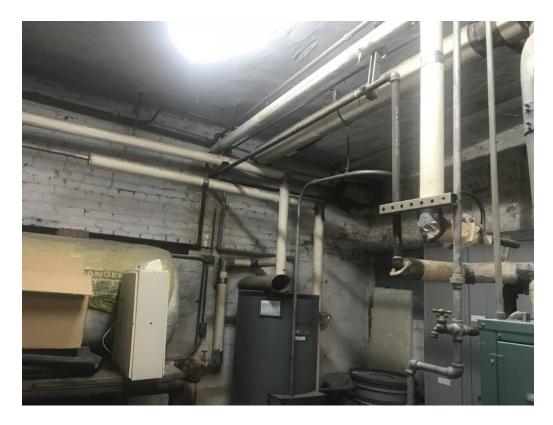
Figure 1-3. First floor mechanical room.

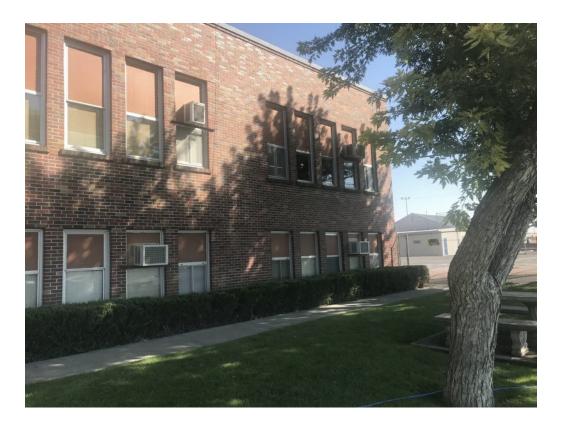
Figure 1-6. Southeast face of the building.

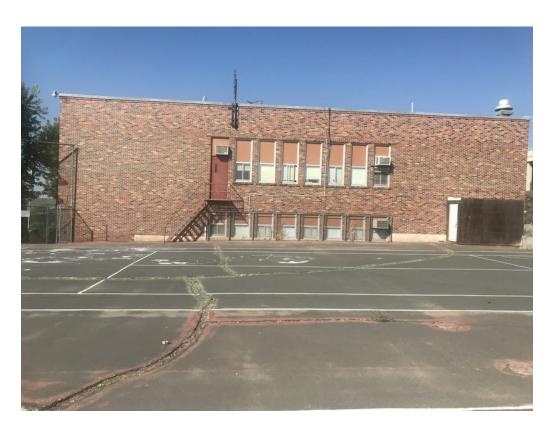
Figure 1-7. East side of building.

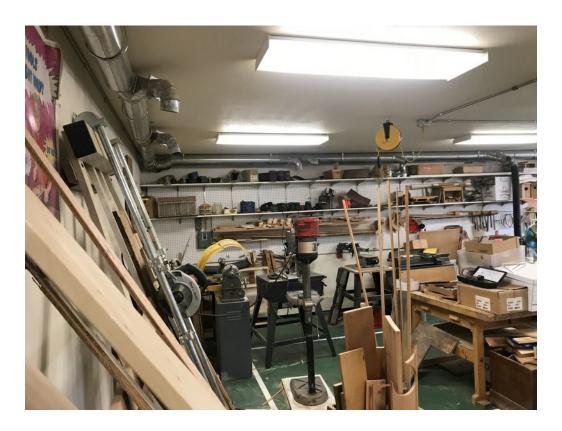
Figure 1-2. Wood shop area.

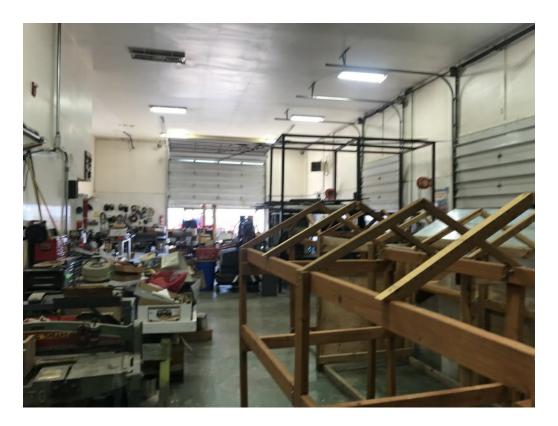
Figure 1-3. Welding shop.

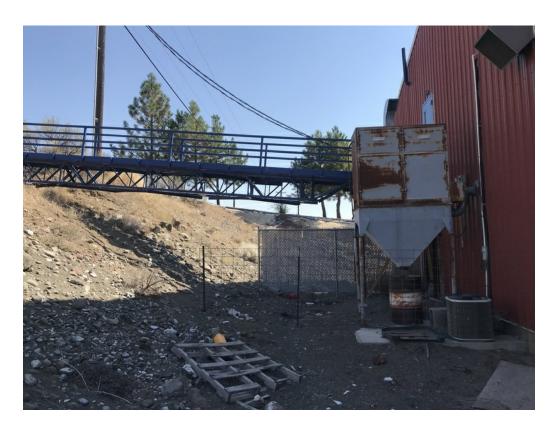
Figure 1-4. North side of building; access bridge to second floor visible.

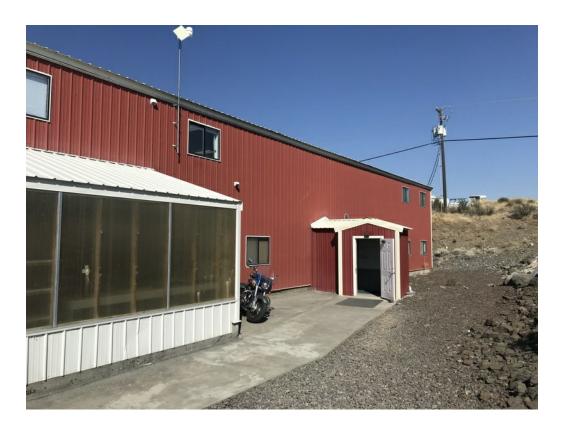
Figure 1-7. East side of building with main entrance door open.
